LOUISIANA DEPARTMENT OF WILDLIFE & FISHERIES

CANEY CREEK RESERVOIR

AQUATIC VEGETATION TYPE MAPS
AND NARRATIVES 2019

APPENDIX III – TYPE MAP HISTORY

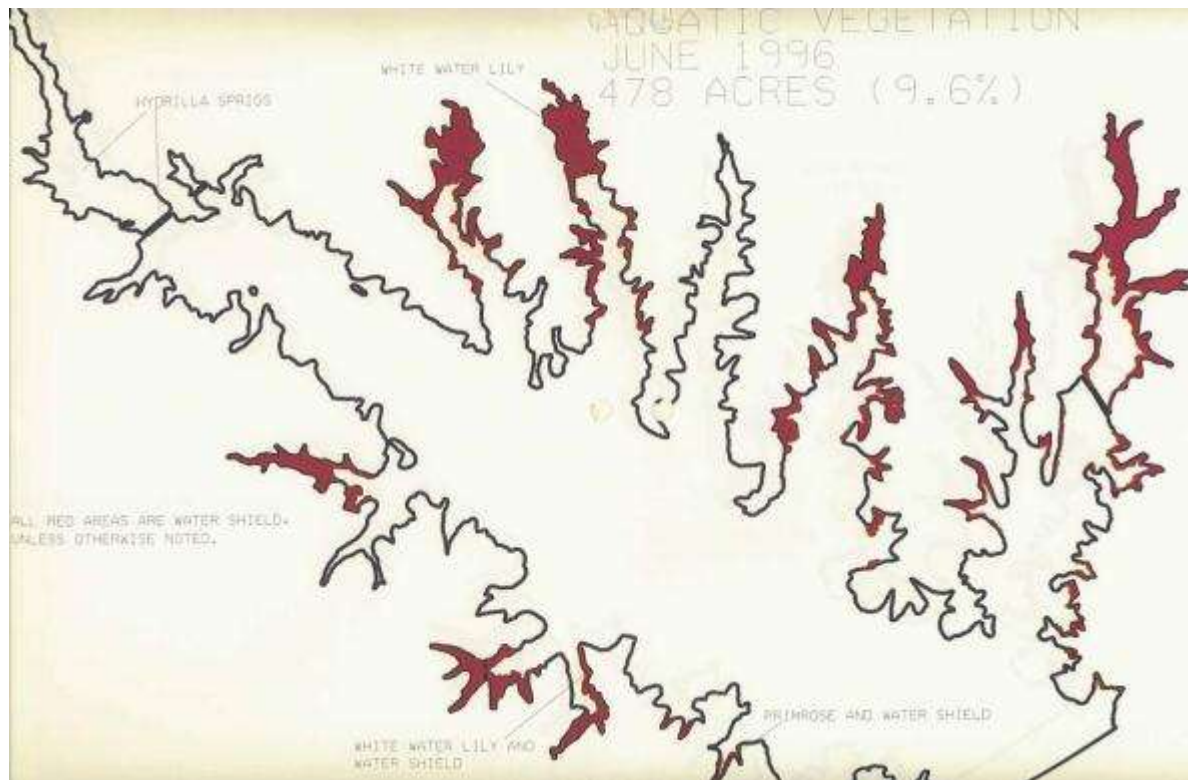
Caney Lake – 1996 Type Map

A total of 21 species of floating, emerged and submersed plants were found in the lake. Bladderwort was by far the most abundant submersed plant. Chara and Southern Naiad would be third in abundance. Mappable floating, emerged and submersed species were associated with the 9.2% coverage.

As per the Caney Aquatic Management Plan, vegetative coverage goal of 15% (750 acre) states If coverage drops below 15%, and j grass carp should be removed or reduced in made to capture or kill some of the fish. Coverage (9.2%) is now below the established a staff meeting to determine what measures are appropriate. If additional vegetative cover is desired grass carp population will need to be removed.

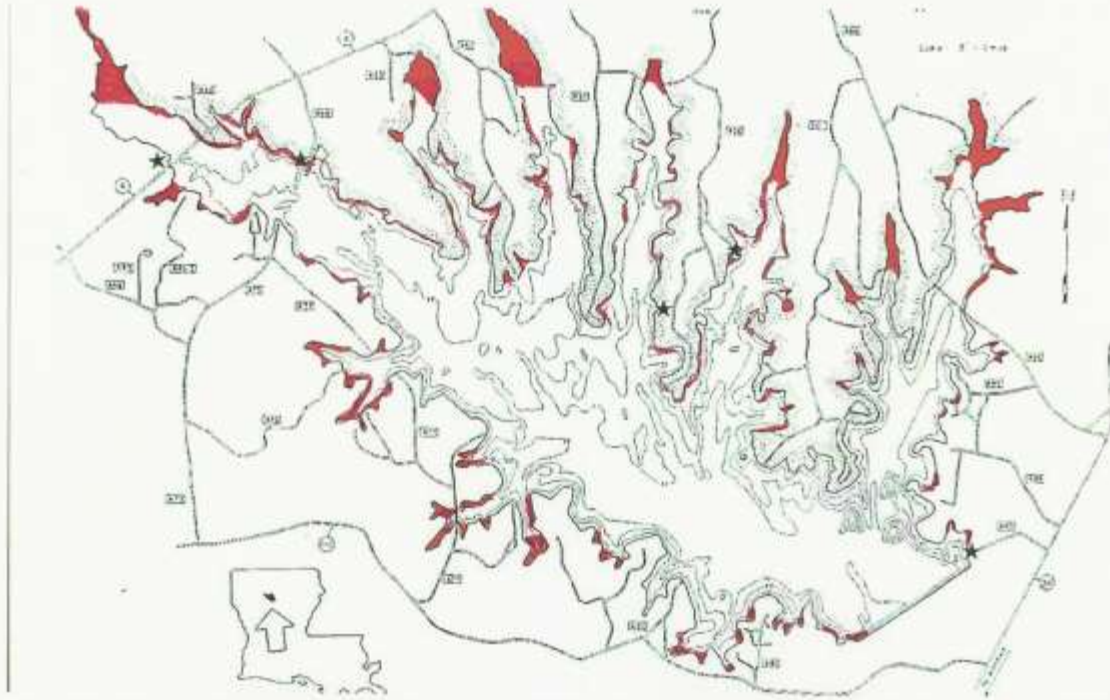
September 2005 Plant Survey

During this year's survey, submergent aquatic vegetation (SAV) was observed in small amounts intermittently around the shoreline and in the backs of coves. The predominant species of SAV found in the lake was bladderwort (*Utricularia spp.*). Other submergent species identified in lesser amounts were:

Water shield and creeping water primrose were found in a fringe to approximately three feet in depth. The largest stands of water shield and fragrant water lily were observed in the shallow ends of the five Northern coves. Southern water-grass (*Luziola fluitans*) was also observed in small patches throughout the lake. Fringes of water hyacinths (*Eichhornia crassipes*) were observed primarily along the Northwestern shoreline. As in the 2004 survey, Illinois pondweed was found in two small patches in the coves of Hancock Creek and Boggy Branch. Fringes of emergent vegetation such as smartweed (*Polygonum spp.*), sagittaria (*Sagittaria spp.*), torpedo grass (*Panicum repens*), wild taro (*Colocasia esculenta*) and lizard's tail (*Saururus cernuus*) were found in a five to twenty foot fringe from the shoreline intermittently throughout the water body. Emergent species were observed to have extended coverage from last year's type map, but not significantly. Total aquatic vegetation coverage is estimated to be 5%. Other aquatic vegetation observed in trace amounts were duckweed (*Lemna spp.*), mosquito fern (*Azolla caroliniana*), pickerelweed (*Pontederia cordata*), spike rush (*Eleocharis baldwinii*), American lotus (*Nelumbo lutea*) and cattail (*Typha spp.*), and aquatic liverwort (*Ricciocarpus natans*).

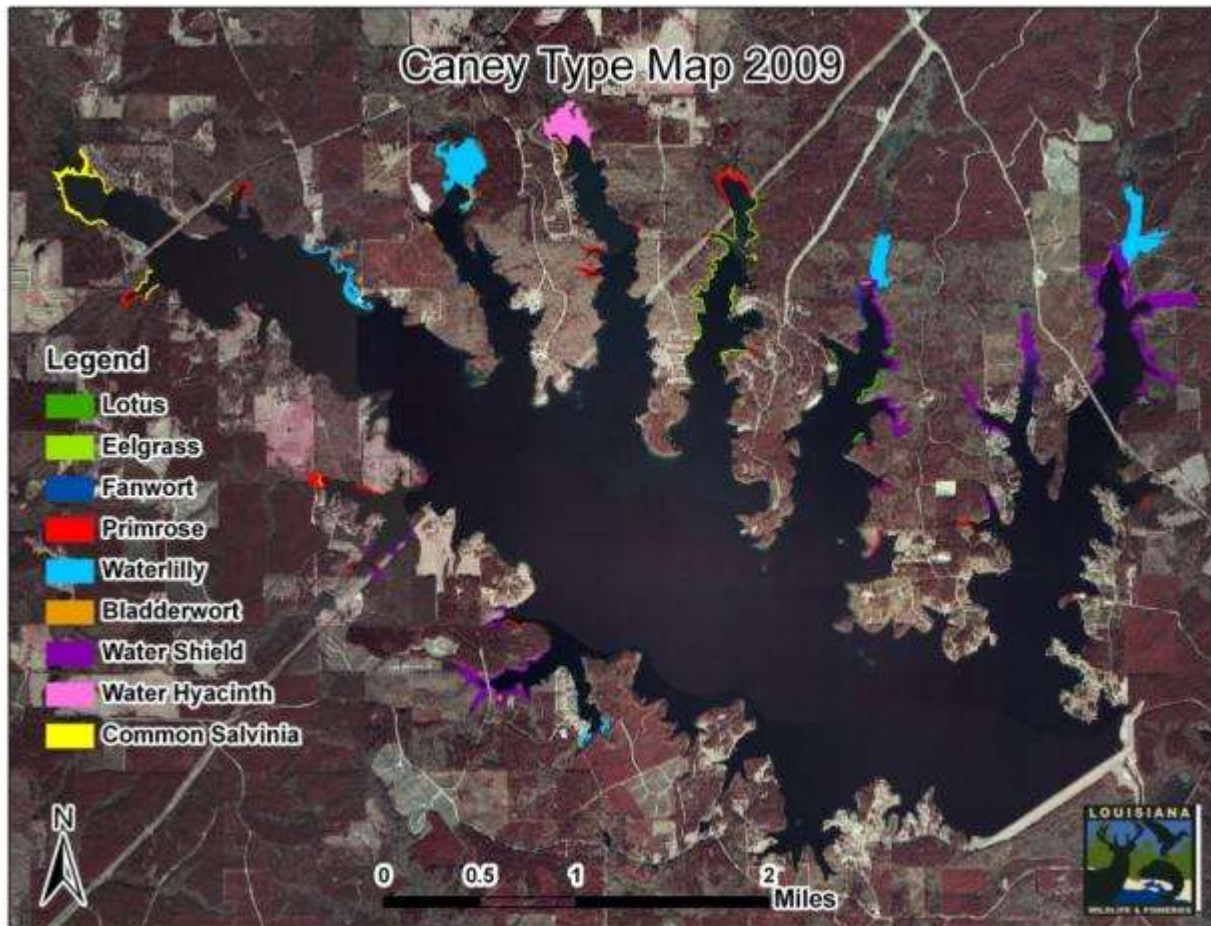
Caney Creek Reservoir Aquatic Type Map August 3, 2010

Caney Lake – Aquatic Vegetation Assessment Narrative and Type Map– 2010

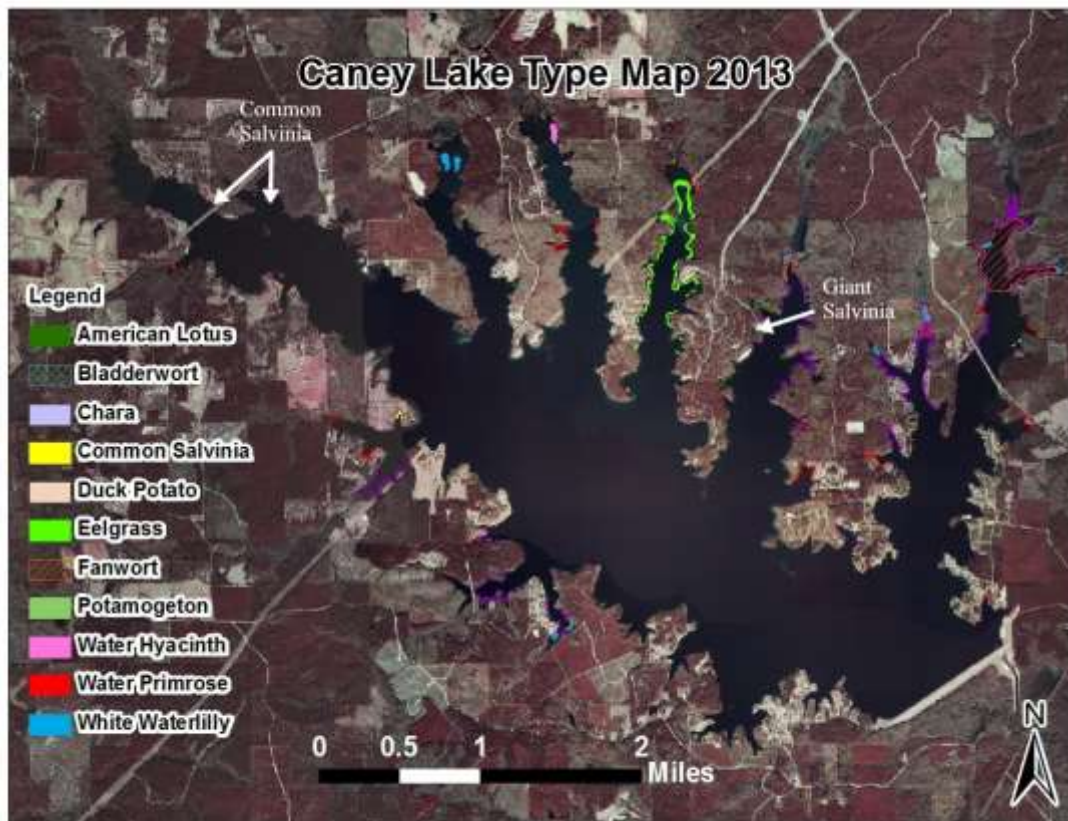
SPECIES LIST
CANEEY LAKE TYPE MAP 2013

Total vegetation coverage for the reservoir is less than 5%, but slowly expanding in some areas. Giant salvinia (*Salvinia molesta*) was found on the lake in 2013 again near the swimming area boat launch in the Jimmie Davis State Park. Salvinia was isolated to the two adjacent pockets near the ramp and quickly treated. At the time of the survey, only a few plants remained. Common salvinia (*Salvinia minima*) could be found in combination with emergent shoreline vegetation in the western reaches of the lake, but was at generally low densities. Submerged aquatic vegetation is limited to the Smith Branch arm where the coverage of fanwort (*Cabomba caroliniana*) and bladderwort (*Utricularia spp*) has remained constant in recent years, and to the expanding eelgrass (*Vallisneria Americana*) population in Clear Branch. Eelgrass densities have increased since low-water periods following the draught of 2010-2011. Plants appear healthy and have expanded across the cove and even a few plants were found in adjacent coves and across the lake. The map below is a representation of the aquatic plant coverage on Caney Lake. A more precise map could not be generated at the time of the survey due to software limitations.

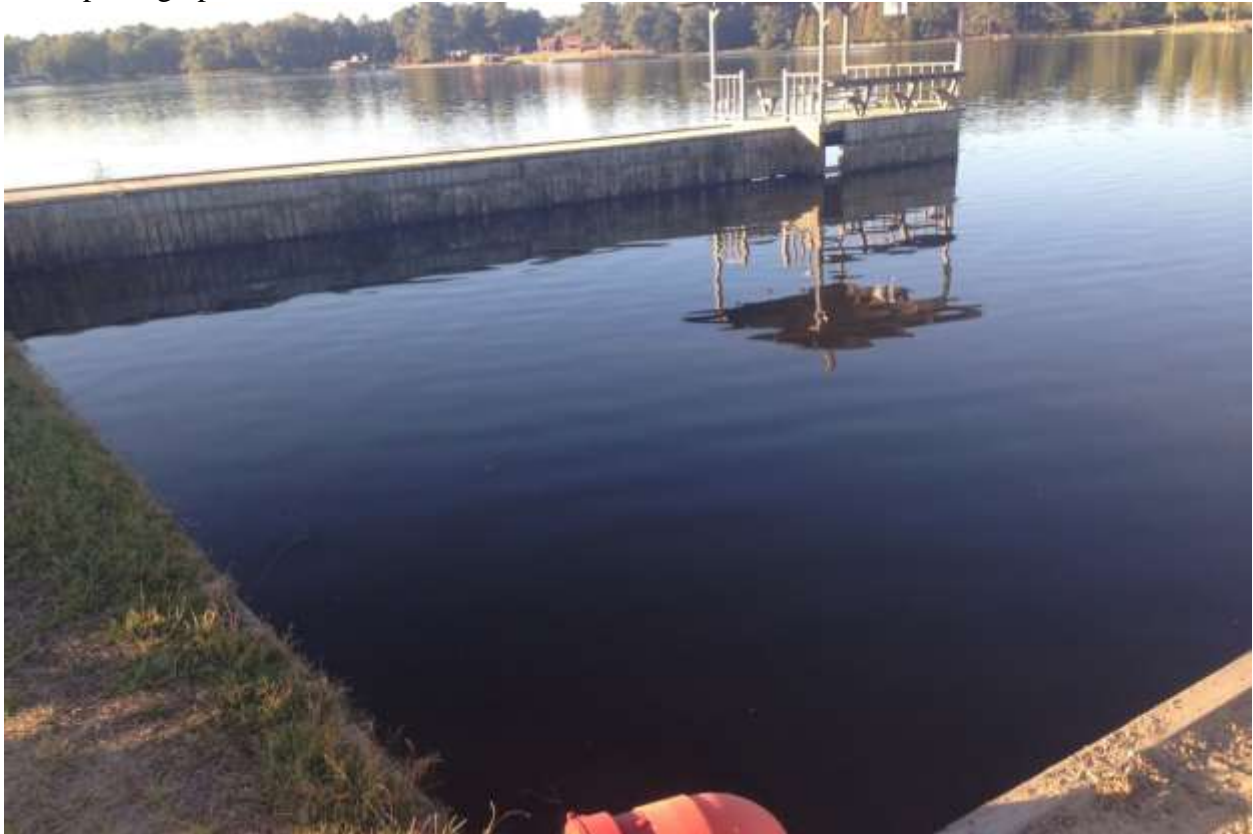
Hydrilla was found in a small patch near Brown's Landing on July 12, 2015. Granular aquathol herbicide was obtained and the area was treated August 20th. The treatment was successful as seen in the photograph below taken on 10/14/15.

Figure 1. Photograph taken October 14, 2015 showing hydrilla infested area near Brown's Landing, post-treatment.

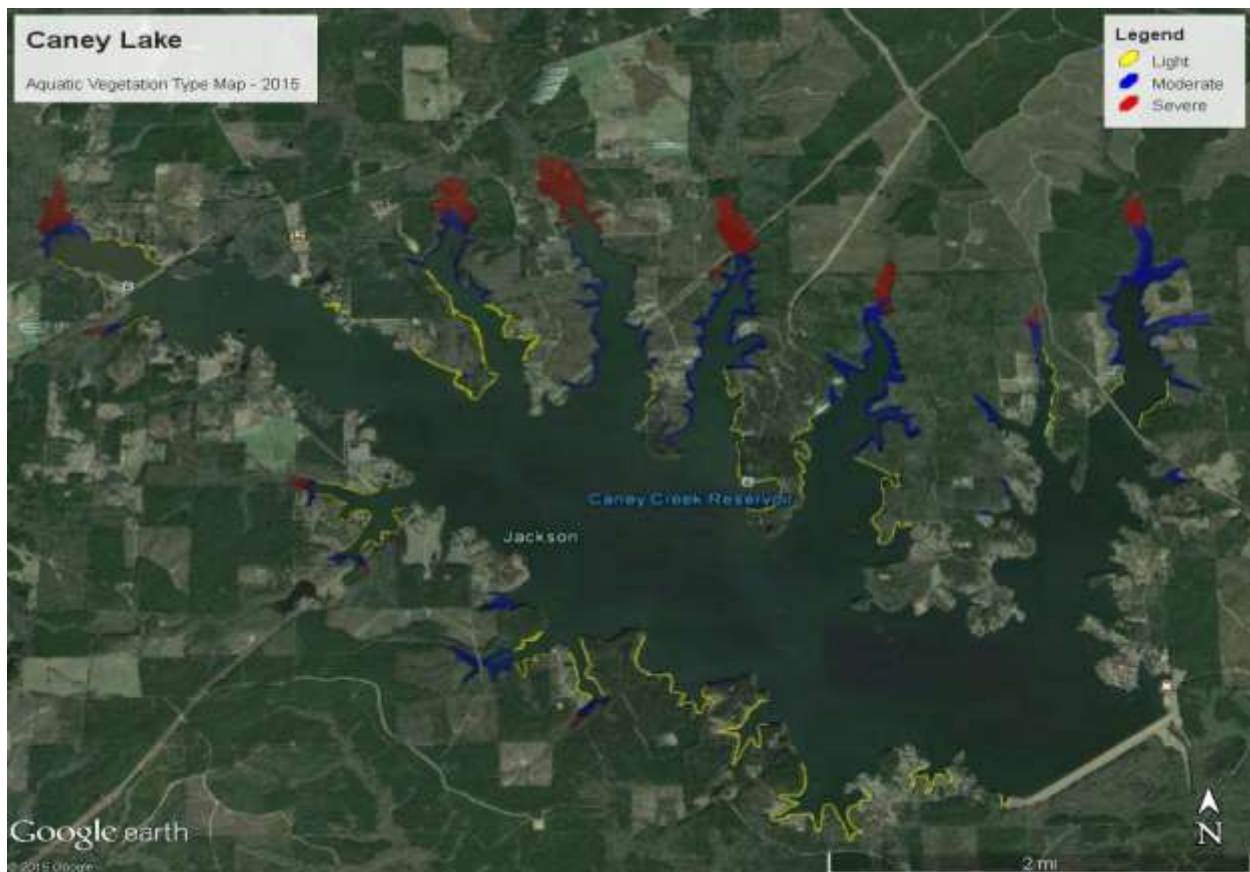
Eelgrass has continued to spread throughout most of the branches on the north side of the lake with the exception of Smith Branch, and there are a few patches of eelgrass in the protected coves on the south side of the lake. Eelgrass was generally found in beds where it was the primary or only species present.

Giant salvinia is present on the west end of the lake and near the state park. While coverage is the highest recorded for Caney, the total acreage remains below 50 acres. Common salvinia was observed in Walsworth Cove and other protected coves on the southwest side.

Figure 2. 2015 Caney Lake Vegetation Type Map.
